## Comparison of Relocatable Commercial Vehicle Washing Systems

SERDP Project SI-1545

SEPTEMBER 2008

Joseph Fleming  
**USDA Forest Service**

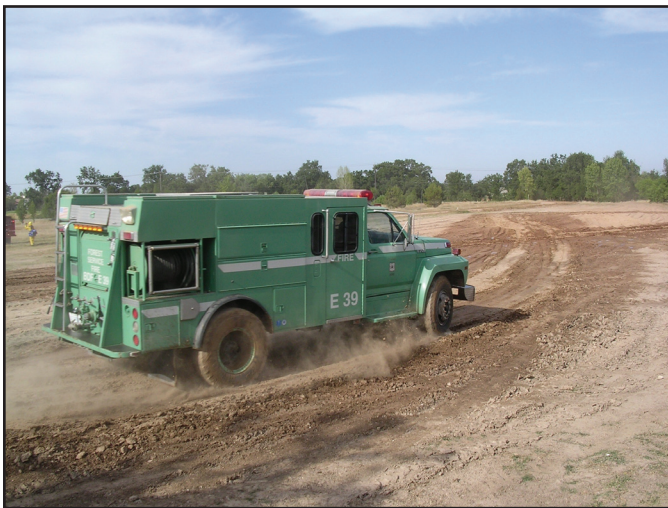
**Vehicle Type 1.** Wildland fire engines (three; only two were used for test cycles).

Figure 2—Wildland fire engines.

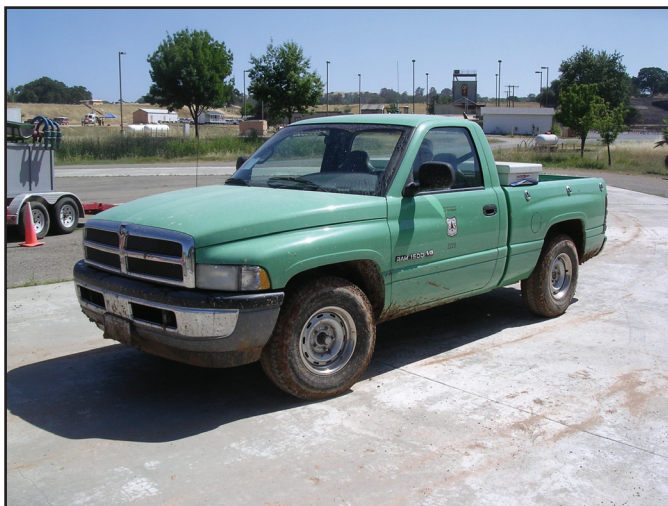
**Vehicle Type 2.** Light-duty trucks (two) and sport utility vehicle (one).

Figure 3—Light-duty trucks and sport utility vehicle.

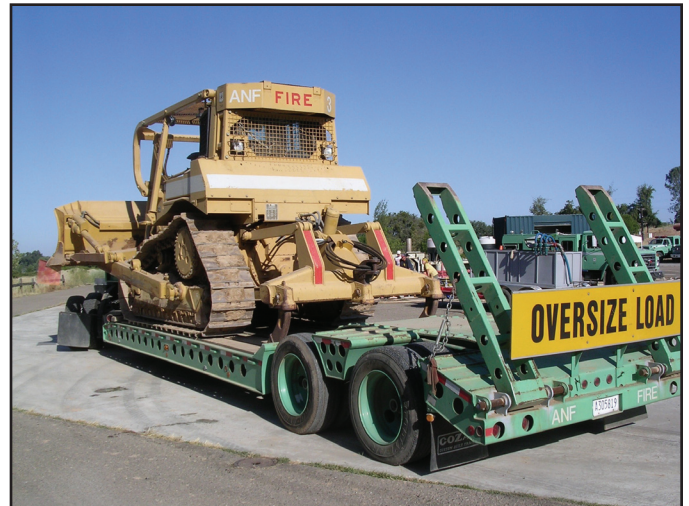
**Vehicle Type 3.** Caterpillar D6 High-Track bulldozer (one).

Figure 4—Caterpillar D6.

Heavy equipment, particularly tracked vehicles like bulldozers, can pick up a tremendous amount of debris. We did not consider it practical to remove the skid pans and covers from the dozer in our test since we were focused on field washing situations with logistical limits on time, tools, and labor. However, we found that manually removing debris from the machines without water was the best first step since the water tends to relocate a lot of the debris without removing it.

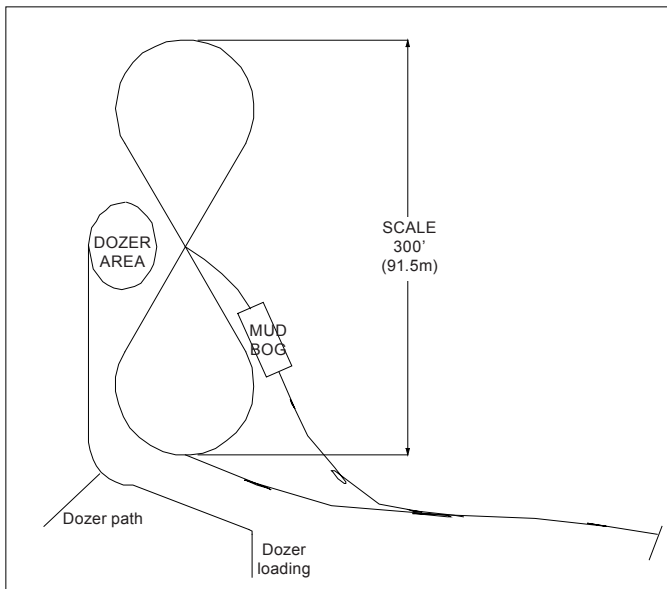
**Figure-8 Section.** After passing through the mud bog we drove the vehicles around a figure-8 course that was approximately a football field long (300 ft) and 100-ft wide. We loosened the soil in the figure-8 area with a roadgrader scarifier after each series of 18 soil-and-wash cycles for the Type 1 and 2 vehicles. In the early morning prior to running a test series with Type-1 or Type-2 vehicles, we applied a full load of water from a 3,000 gallon water truck to the figure 8. As the test progressed, typically after about 9 cycles, the figure-8 section would start to dry out somewhat and we would spray another 3,000-gallon (gal) load of water on the course. The lap distance around the figure 8 was approximately 761 ft and the distance from the helipad to the test course was approximately 1,254 ft. The road between the course and the helipad has a crushed-gravel surface. A trip from the helipad to the test course, including one pass through the mud bog and 2.75 laps around the figure 8, constituted the test distance.

Figure 5—Figure-8 course drawing.

We would drive the wheeled vehicles through a fabricated mud bog and then 2.75 times around a figure-8 course before returning them to the washing area on the helipad (figure 5). We know that it is very hard to control multiple natural and human-induced variables simultaneously so we tried to keep some of the human inputs, such as driving speed and course tracking constant, but our results seem to suggest that we may have experienced some form of boundary creep with respect to speed and tracking. We cannot know for sure how much variance there was since we did not have active speed and position monitoring.

**Type-3 Vehicle (Bulldozer): Test Course.** We used an area near the intersection of the figure-8 course for the bulldozer workout routine (figure 5). We sprayed the area with approximately 700 gal of water, 1 to 2 hours before starting. Our bulldozer "workout" regimen described below included plowing, back-dragging, ripping, pivoting, and moderate-speed traversing.

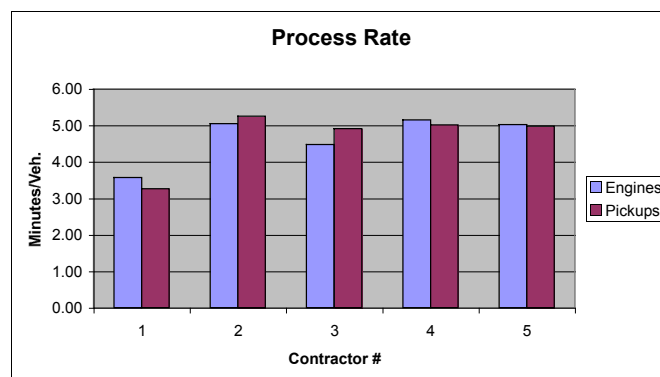
Figure 11 compares the five systems with regard to the average process rate per vehicle.

Figure 11—Process rate.

The Forest Service has adopted a maximum average process time for wheeled vehicles in some regions. The interim standard for Region 1 (MT, ND, ID, WY, SD) requires that any wash system used on an EERA be capable of washing wheeled vehicles in no more than 5 minutes per vehicle on an average of 10 vehicles. We adopted the 5-minute limit for wheeled vehicles in our testing in lone. Occasionally a contractor would run beyond the 5-minute mark, but we made note of that and stopped them as soon as possible afterward. We also note that the number of personnel employed in the washing varied from two to five, another variable that was not controlled here. Those who used a larger number of personnel appear to have taken less time per vehicle, which seems logical.

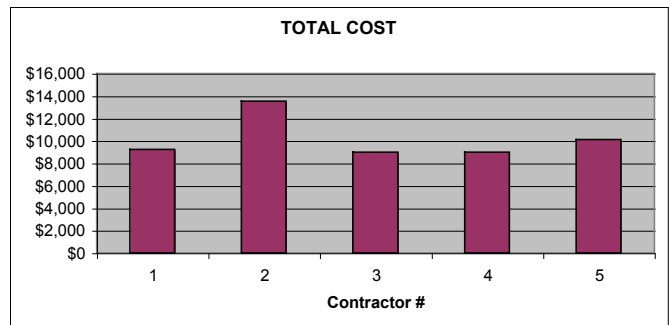
Figure 12 gives a comparison of the five different systems in terms of total cost to run the test at lone. Some contractors were stationed within a few hours of lone while others had to travel for days to get there. Some carried all of their equipment in light-duty trucks while others needed heavier vehicles like a flatbed semitrailer, forklifts, or multiple-cargo trailers. We did not factor in the initial cost of bringing the contractor's equipment to lone in cost

figures 12 and 13, instead we used their daily rate for EERA rental divided by 5 days; one for set-up, 3 vehicle-washing days, 1 for cleanup and teardown.

Figure 12—Total cost.
